This report is prepared exclusively for **Client Name**  
Inspected On: **01-21-2025**

Home Inspections DMV, LLC  
301-250-3711

Heriberto Interiano, MD, D.C & VA State  
License #MD 34937, VA 3380002208

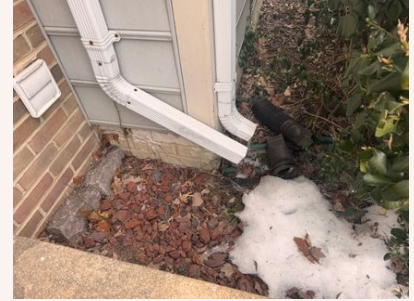
**🔧 (G1-2) Recommended Maintenance:**  
**DOWNSPOUTS DISCHARGE NEAR FOUNDATION**

Downspouts are discharging adjacent to the foundation. This can cause foundation settlement or basement moisture problems. Make sure all downspouts discharge into a proper tight-line system that diverts water at least 5 feet away from the foundation.

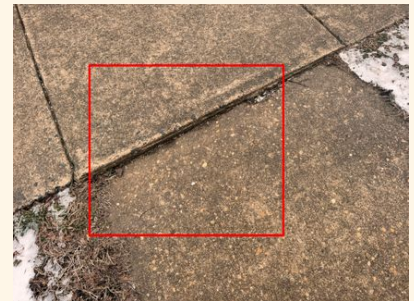
**🔧 (G1-3) Repair:**  
**TRIP HAZARD IN WALKWAY**

The front walkway flatwork has settled creating a trip hazard. Hire a qualified general contractor to repair to eliminate trip hazard and ensure a reliable walking surface.

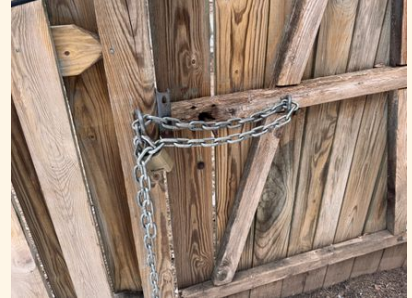
##### **FENCE HAS BEEN CHAINED WITH LOCK**

The rear fence gate has been closed with a chain and lock.  
Request key from sellers and test as needed.

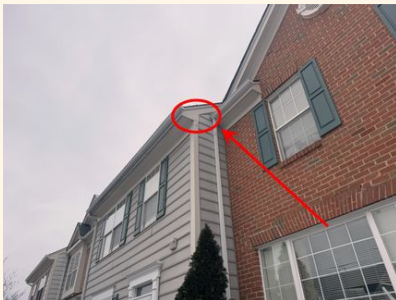
*Wood decay in fascia material*

Hire a licensed general contractor to further evaluate and repair the exterior siding system. Repair and replace all damaged and decaying exterior wood as needed.

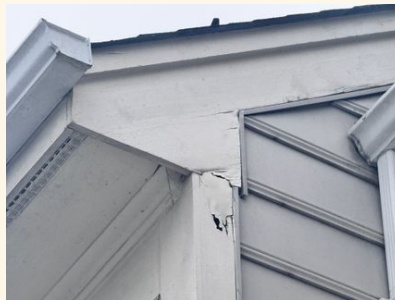
*Wood decay in fascia material*

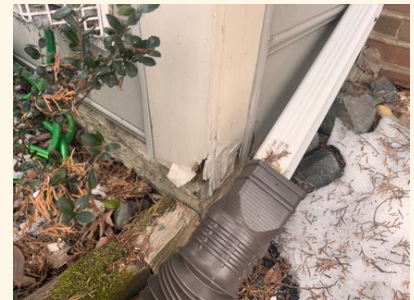
*Wood rot close to the downspout*

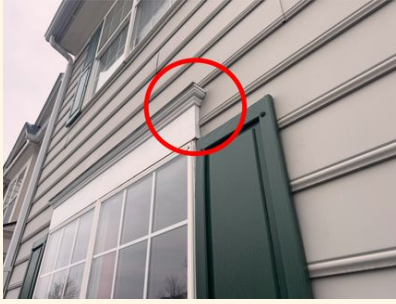
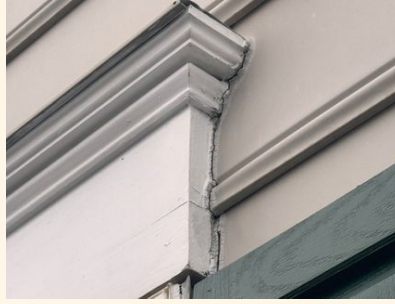
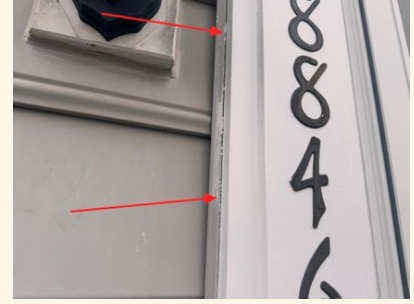
### 🔧 (E-3) Repair: **SIDING MAINTENANCE NEEDED**

Implement painting and/or caulking repairs as recommended by a qualified contractor.

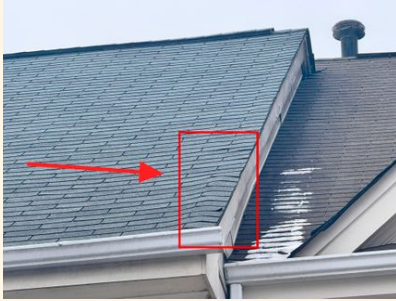
✂️ (RCG-1) Repair: **MISALIGNED SHINGLES/ KICKOUT FLASHING MISSING**

The lower right corner of the roof shows misaligned shingles, which could lead to water runoff issues and increase the risk of water intrusion. Additionally, kickout flashing is needed to direct water into the gutter and prevent damage to the siding/fascia. A professional roofing contractor should assess and address these issues to ensure proper function and durability.

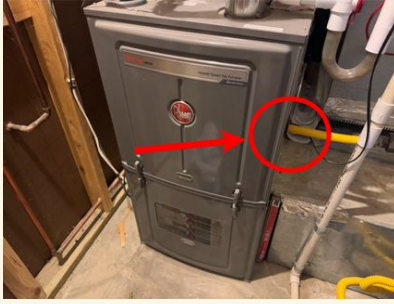
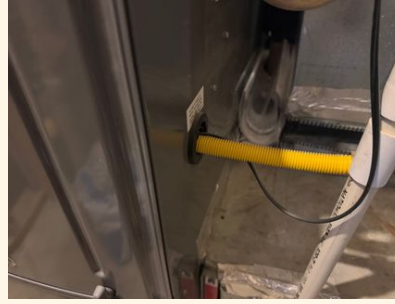
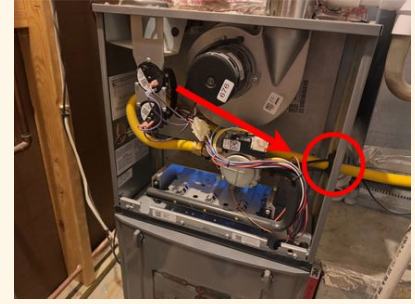
### **(FSD-2) Repair: IMPROPER USE OF FLEXIBLE GAS CONNECTORS**

Flexible gas connectors should not run through the walls of appliances. Use rigid steel pipe only. Have this further evaluated and repaired by a qualified plumber or gas appliance technician.

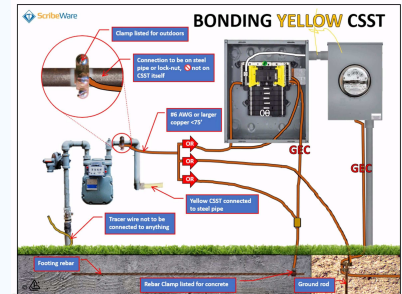
### 🔍 (FSD-1) Due Diligence: **NO CSST BONDING FOUND**

The 2009 edition of NFPA 54, National Fuel Gas Code, includes new requirements for special bonding for CSST gas piping systems to the grounding conductor of the building's electrical system to reduce the possibility of damage by lightning strikes by reducing the electrical potential between metallic objects and building systems, including gas distribution. I was unable to locate a bonding connection for the CSST during the inspection today. Have this further evaluated and repaired as recommended by a qualified CSST installer.

- It is possible that bonding is present and was simply not found
- This building pre-dates requirements for bonding so it is more likely the gas piping was never bonded.

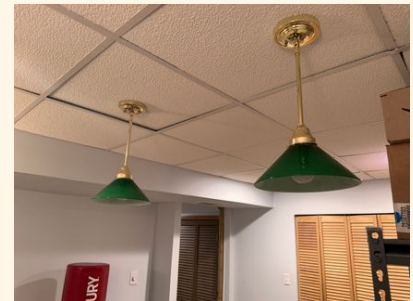
Basement light fixture

### 🔧 (EDF-1) Repair: INOPERATIVE LIGHTS

Inoperative lights were found in the basement. Have all inoperative lights further investigated and repaired as needed. If a new bulb does not correct the problem, consult with a licensed electrical contractor.

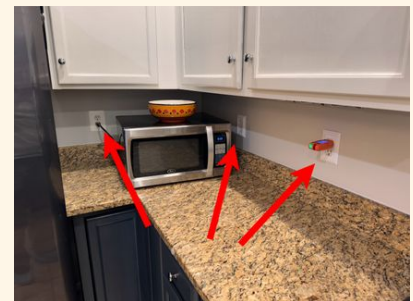
### 🔧 (EDF-2) Repair: GFCI PROTECTED DEVICE DID NOT TRIP

The GFCI protected receptacle in the kitchen did not respond to testing and may be defective - it did not trip when tested. Have this receptacle repaired or replaced as needed.

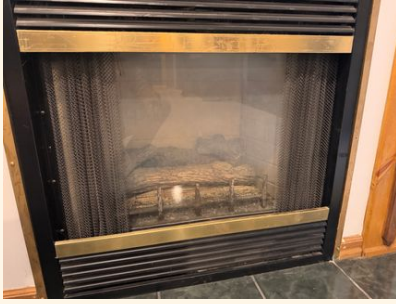
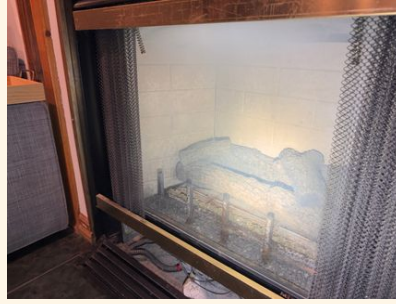
The gas log fireplace was shut off at the time of inspection. I do not like to light these when they are shut off as I do not know why they were shut off and there could be a safety reason. Also, glass pane is foggy. I recommend having this gas log fireplace clean and serviced by a qualified contractor and made operable as needed.

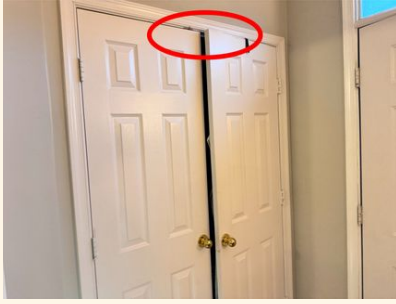
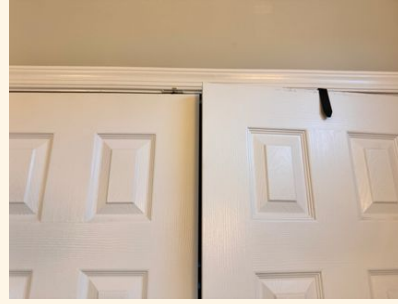
The closet doors to the entrance foyer closet are not latching correctly and requires adjustment so the door latches closed.

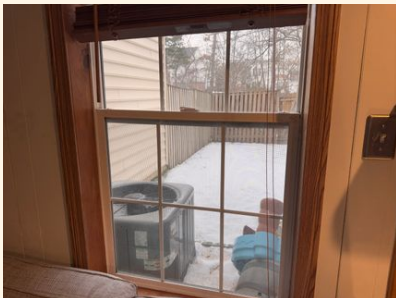
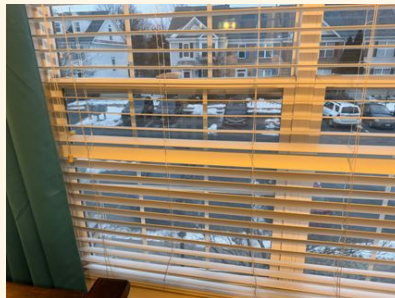
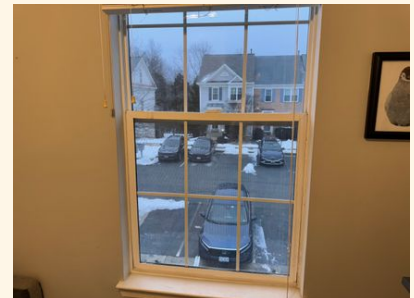
- Some windows in the home are not operating and may be painted/sealed shut.
- Missing window hardware was noted
- Condensation noted
- Many of the windows are single pane glass - these older windows do not comply with modern energy efficiency standards

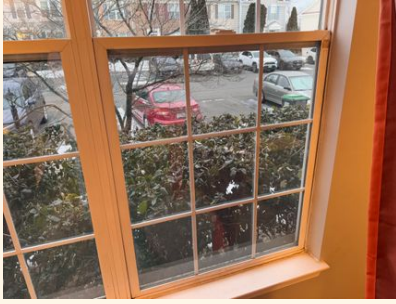
*Family room windows are hard to open*

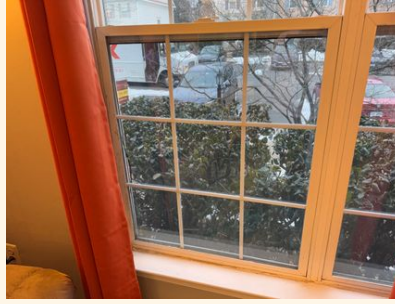
*Broken tilt latch*

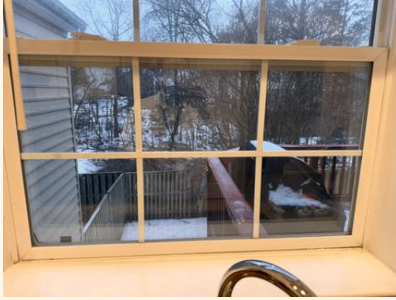
*Kitchen window sealed shut with caulking*

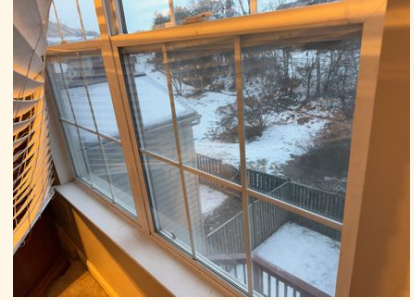
*Main bedroom windows do not stay open*

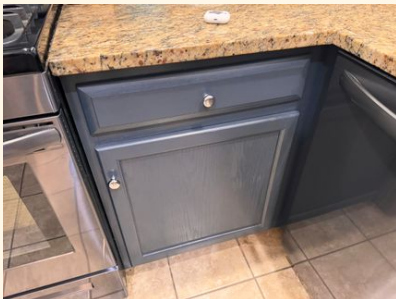
A kitchen cabinet drawer adjustment is needed for proper operation of the kitchen cabinet as is in conflict with the dishwasher.

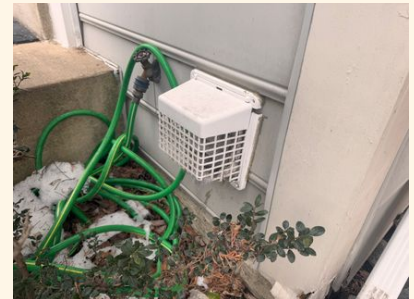
The [dryer exhaust duct](#) termination at the exterior of the building is covered with a screen. This is a potential safety hazard that could block lint and cause a fire. Replace this vent cover with a cover that has a backdraft damper.

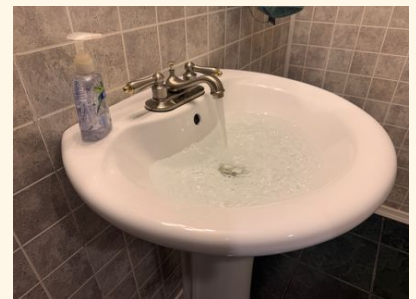
*Basement bathroom sink*

A slow drain was noted at the basement bath sink. Repair as needed so the drain keeps up with the fixture supply.

- This often involves just cleaning out the trap.

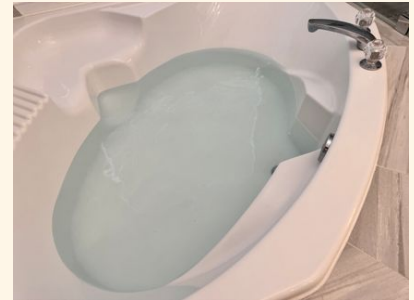
*Main bathroom tub*

The main bath bathtub drain is slow and appears to be obstructed. Repair as needed for reliable drainage.

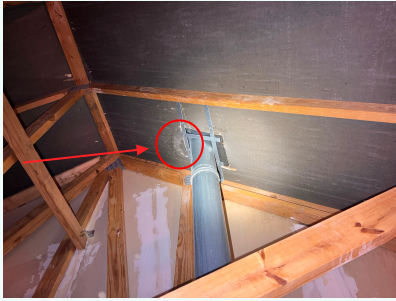
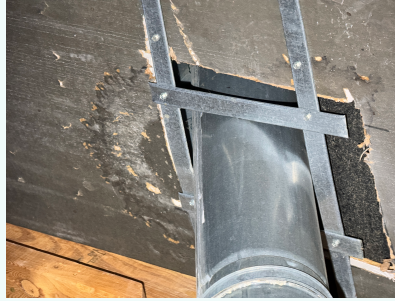
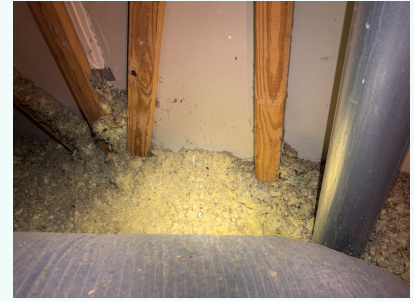
A stain was observed on the FRT plywood around the chimney flue, indicating a past moisture issue. No active moisture was detected on the insulation, suggesting the issue has been resolved. It is recommended to inspect the chimney flashing and monitor the area periodically to ensure no recurrence.

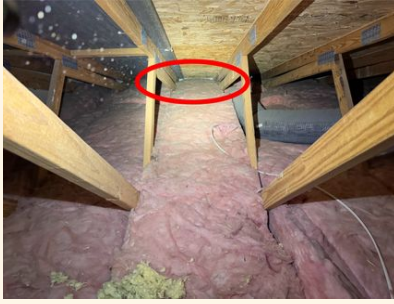
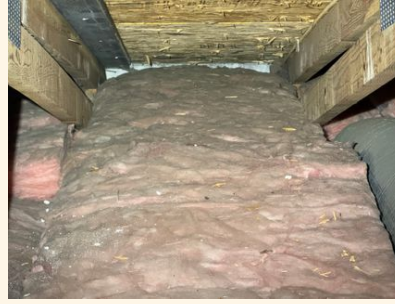
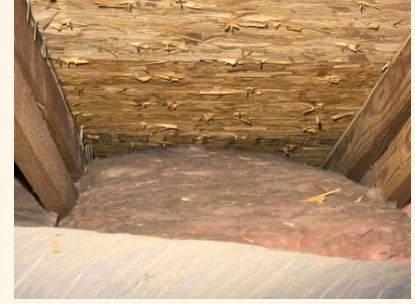
Cardboard baffles have not been installed in the rafters near the eaves in the attic. This has allowed the fiberglass batt insulation to block ventilation from the soffit. This can inhibit proper ventilation of this roof cavity and can lead to heat build-up and seasonal moisture problems. It is recommended removing insulation away from the roof decking in these areas as is possible - this will be difficult work due to the tight space restrictions. Where possible baffles should be added though this could be difficult at this point.
