This report is prepared exclusively for **Client Name**  
Inspected On: **01-21-2025**

Home Inspections DMV, LLC  
301-250-3711

Heriberto Interiano, MD, D.C & VA State  
License #MD 34937, VA 3380002208

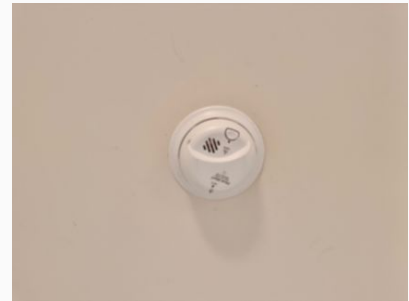
During a home inspection, a representative sample of smoke alarms is tested using the test button on the alarms. This test does not evaluate the sensor's accuracy; it simply verifies whether the unit is powered. Fire marshals recommend updating smoke alarms every ten years and changing batteries bi-annually to ensure reliability. Current data suggests using photoelectric technology in smoke alarms for enhanced fire detection and to minimize false alarms, which can lead to the disabling of this crucial safety system. Unfortunately, determining whether an alarm uses photoelectric or ionization technology requires removing the unit, and accurately testing a smoke alarm system for reliability, age, and sensor type is surprisingly complex. Many homes have half a dozen or more alarms, further complicating the assessment. A comprehensive evaluation of smoke alarms falls outside the scope of a standard home inspection. For optimal fire safety, it is recommended that homeowners take an active role in understanding, servicing, and maintaining their smoke alarm systems to ensure the safety of all building occupants. [For more information, please read this link.](#)

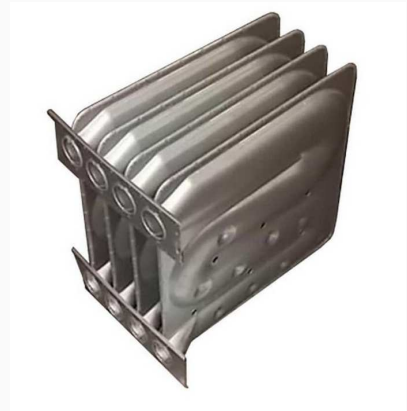
*This house has a gas forced air furnace. A critical component to all combustion heating equipment is the heat exchanger. This is the welded metal assembly inside the furnace that contains the products of combustion so that moisture, carbon monoxide and other products of combustion do not mix with interior air and get safely vented to the exterior. Heat exchangers on modern furnaces have an average life expectancy of 15-20 years. Unfortunately, heat exchangers are concealed inside the heating equipment; they are not visible and specifically excluded from a home inspection. Cracks in heat exchangers may be concealed and can pose a potential safety hazard.*

*This shows an image of a heat exchanger.*

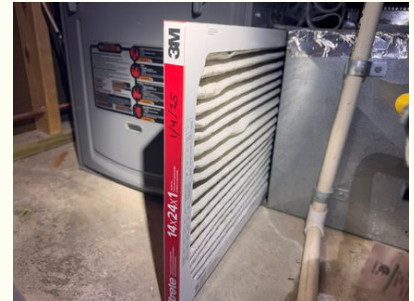
*The heating and cooling system has disposable air filters installed. These should be changed quarterly or more to ensure proper airflow at the furnace. Be sure to install the filters with the arrows pointing in the same direction as the airflow in the furnace.*

#### ✦ Inspection Notes: Filter size: 14x24x1

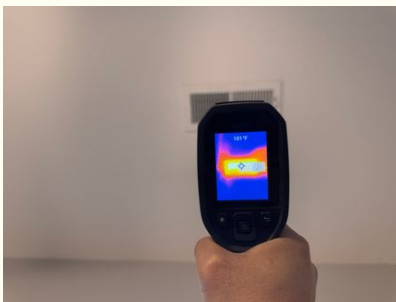
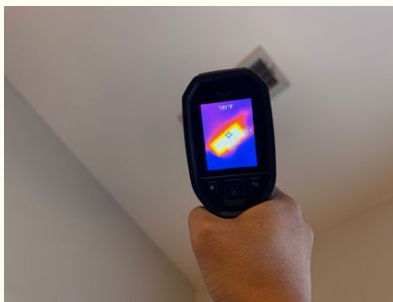
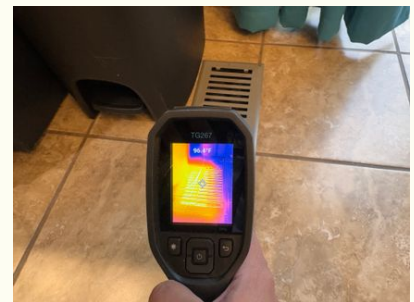
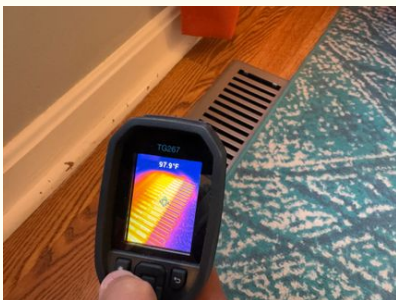
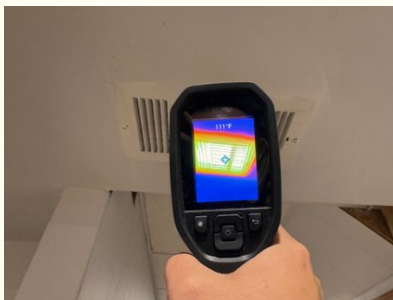
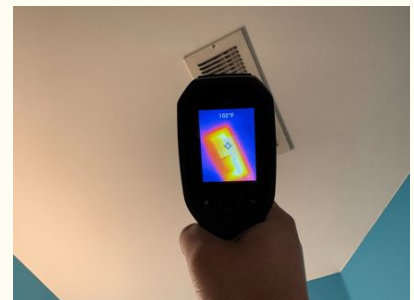
✦ **Inspection Notes:** Thermal images show approximate temperatures at heating registers. I use these images just to show the system was generally functioning during inspection. These are representative photos.

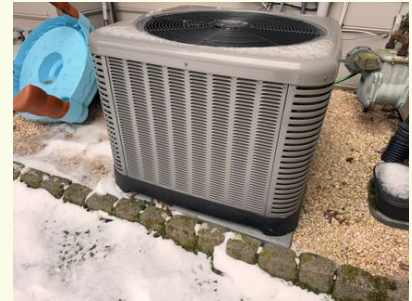
**TOO COLD TO TEST AC**

The air conditioning system and condensate control system could not be tested during inspection. Outdoor temperatures should exceed 65 degrees F for at least 24-hours or the air conditioning equipment can be damaged by testing. It is recommended having this system serviced and inspected prior to the next cooling season.

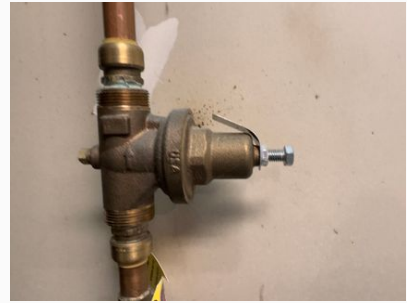
*This house has a pressure-reducing valve to control the water pressure. This typically turns the piping system for the building into a closed system. Closed systems require some type of thermal expansion device, typically provided by an expansion tank at the water heater. Though other options exist, such as a Governor 80.*

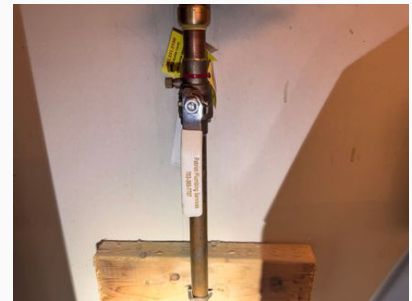
### **Main Water Shut-off Location:** Basement

*Main water shutoff valve located behind the clothes washer*

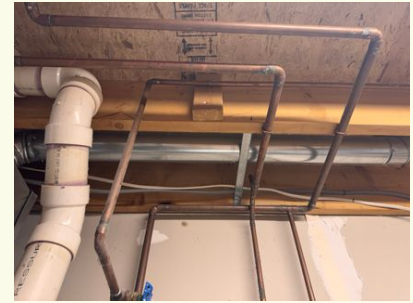
Please note that the supply pipes are concealed behind insulation and finishes and visual inspection was limited. Determination of the supply piping materials used here is an educated guess based on the materials that were visible coming out of the wall and below fixtures.

*Copper distribution lines*

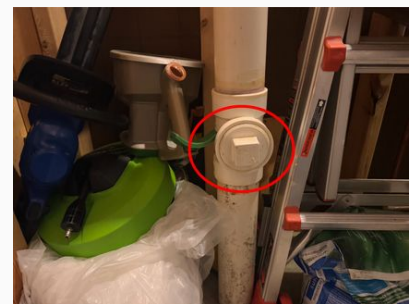
**Location of Sewer Cleanout:** Basement

*This shows the location of the sewer cleanout found during inspection - basement.*

*Inside the basement closet*

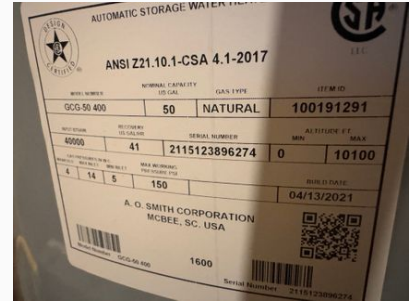
**Data Plate:** Shown Here

*This shows the data plate for this water heater.*

**Size:** 50 gal

**Age:** 2021

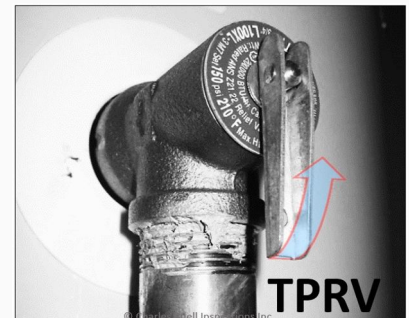
*The arrow shows how a TPRV can be tested*

*Most codes defer to manufacturer instructions and I favor those recommendations. The yellow tag on the valve states clearly the termination should be 6" above the floor which is more consistent with the UPC code requirements.*

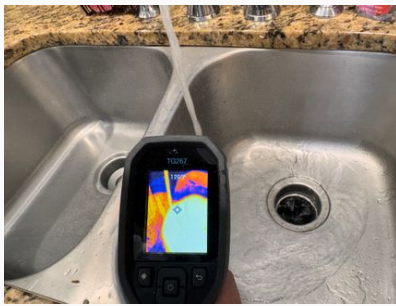
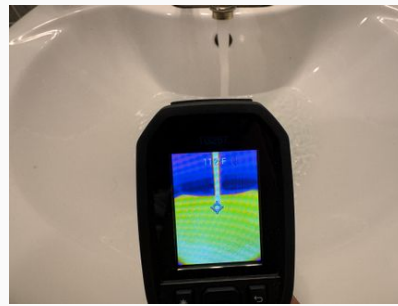
*This thermal image shows approximate water temperature at the time of inspection.*

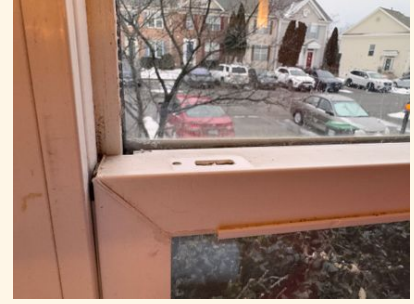
*Kitchen window sealed shut with caulking*

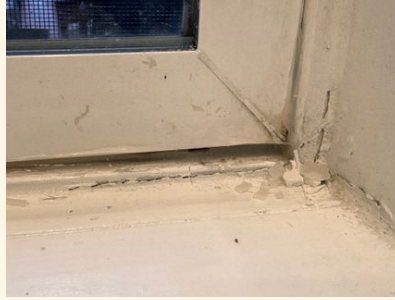
*Sealed shut with caulking*

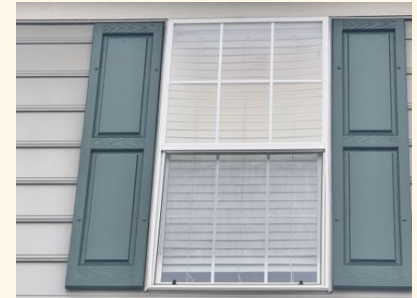
##### **LOST SEAL / FAILED INSULATED GLASS UNIT**

The exterior front right side window were presenting with a cloudy appearance. Often referred to as a, "lost seal," the cloudy appearance cannot be cleaned. Affected glass typically requires glazing repair or replacement.

- This is a common occurrence in insulated glass, especially as they age and on sun-exposed sides of the building.

Hire a glass replacement company to further evaluate the windows and glass here and replace/update all insulated glass units with lost seals.

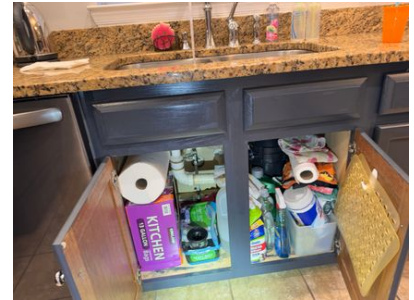
No active leaks observed at the time of the inspection.

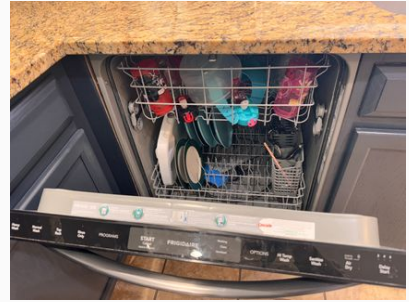
**Dishwasher:** Not Operated

*Though kitchen appliances are generally beyond the scope of a home inspection, I was unable to run the dishwasher as it was being used. No signs of leakage or water damage were visible. It is always wise to monitor the dishwasher after moving in.*

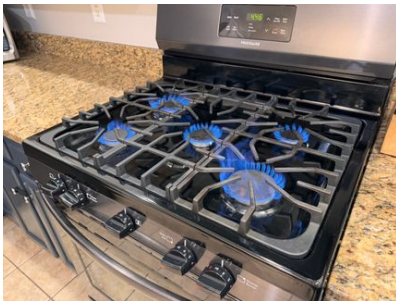
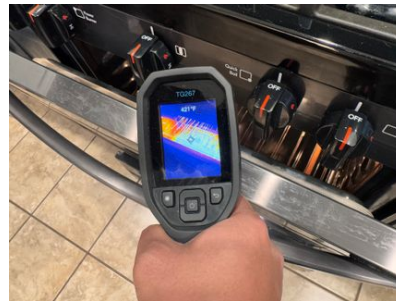
The oven and cooktop were tested during the inspection and were operable. Ovens are tested in bake mode only. Appliances are generally beyond the scope of a home inspection but are tested for basic function as a courtesy. This does not include testing to see if the thermostat is accurate, for example.

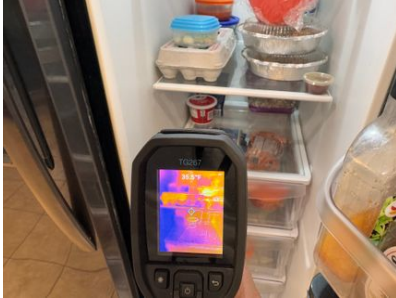
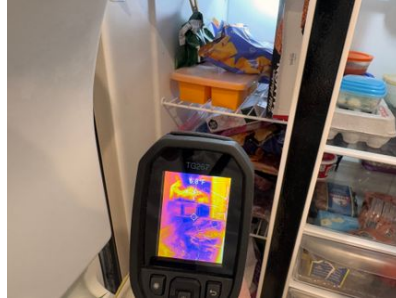
The refrigerator water / ice system seems to employ a filter. Inquire with the seller for additional information regarding replacement schedule and the types of filters needed.

Thermal images show the freezer and refrigerator working during the inspection.

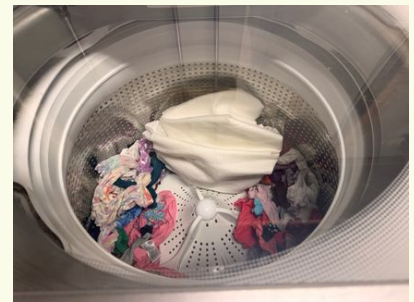
#### **CLOTHES WASHER NOT TESTED**

The clothes washer was not tested today as clothes were present in the appliance.

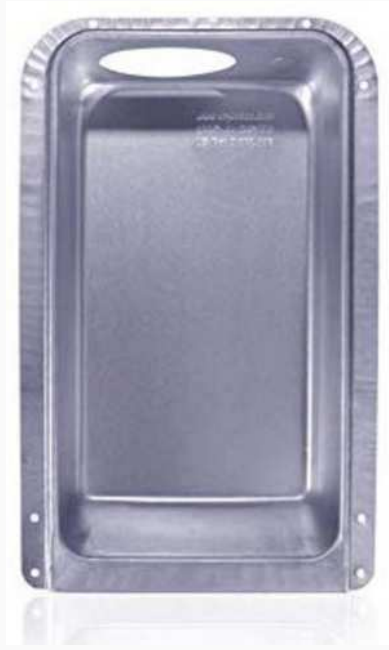
This shows an example of a dryer vent box

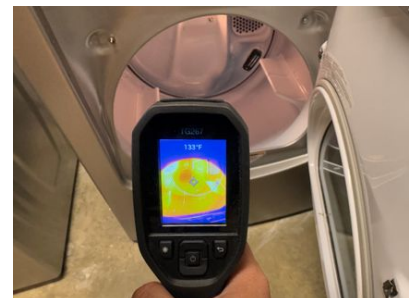
Thermal image shows the dryer was tested and operating at the time of inspection.

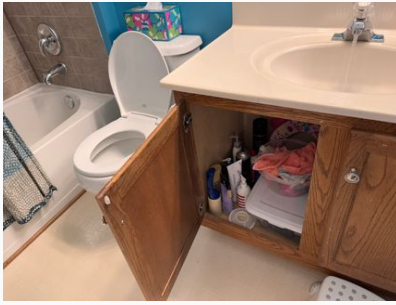
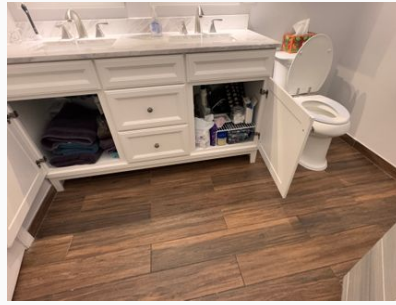
After running water on bathroom fixtures, no leaks were detected.

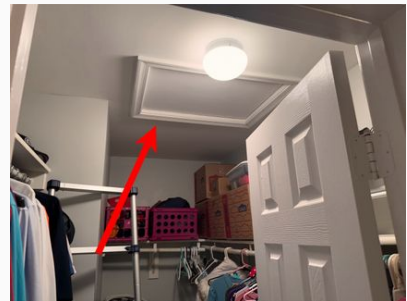
*This shows the location of the attic access in the: MAIN BEDROOM CLOSET*

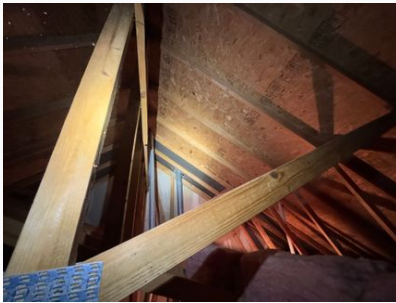
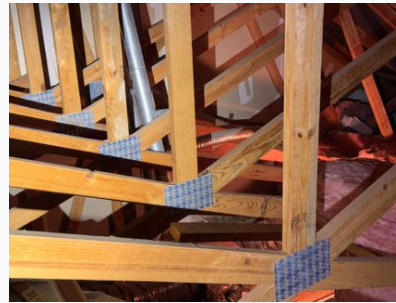
*Pictures of roof structure*

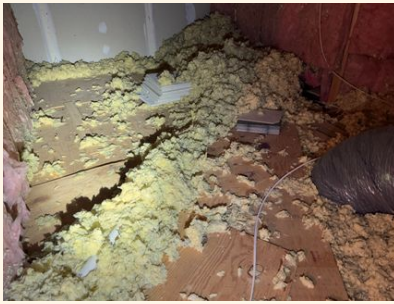
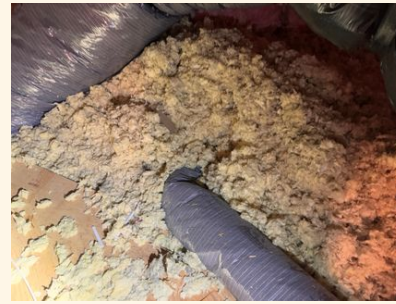
### (A-3) Repair: **ATTIC INSULATION ADJUSTEMENT RECOMMENDED**

Localized tune-up repairs are needed to the attic insulation to ensure reliable performance. During inspection the following observations were noted:

- Blown in insulation has been disturbed by contractors or prior attic access

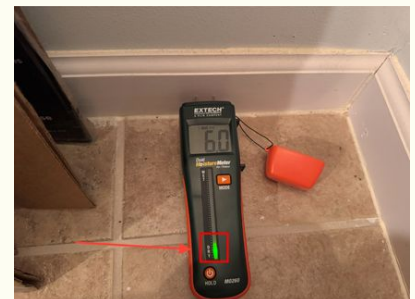
#### **NO SIGNS OF BASEMENT MOISTURE WERE FOUND**

I inspected all around the basement for signs of moisture and / or moisture control problems. No water stains, or damaged baseboard were noted and no signs of paint touch up near the floor. Basement did not smell musty at the time of inspection and seems to be performing well to date.

*Dry at the time of the inspection*
